Appendix B-5

Eastern Bypass Construction Debris Area Photographs

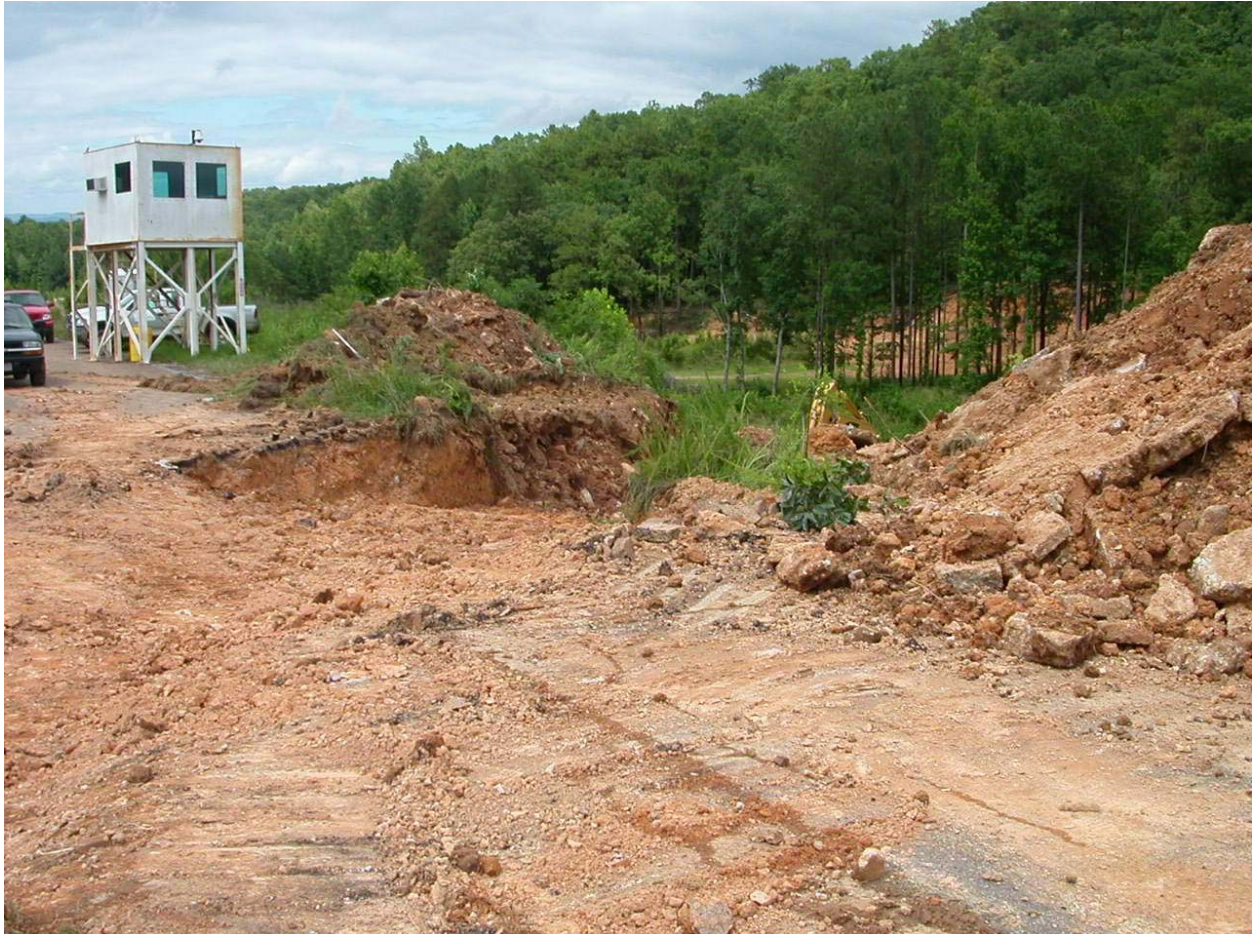
Armored control booth for safety observation next to culvert.

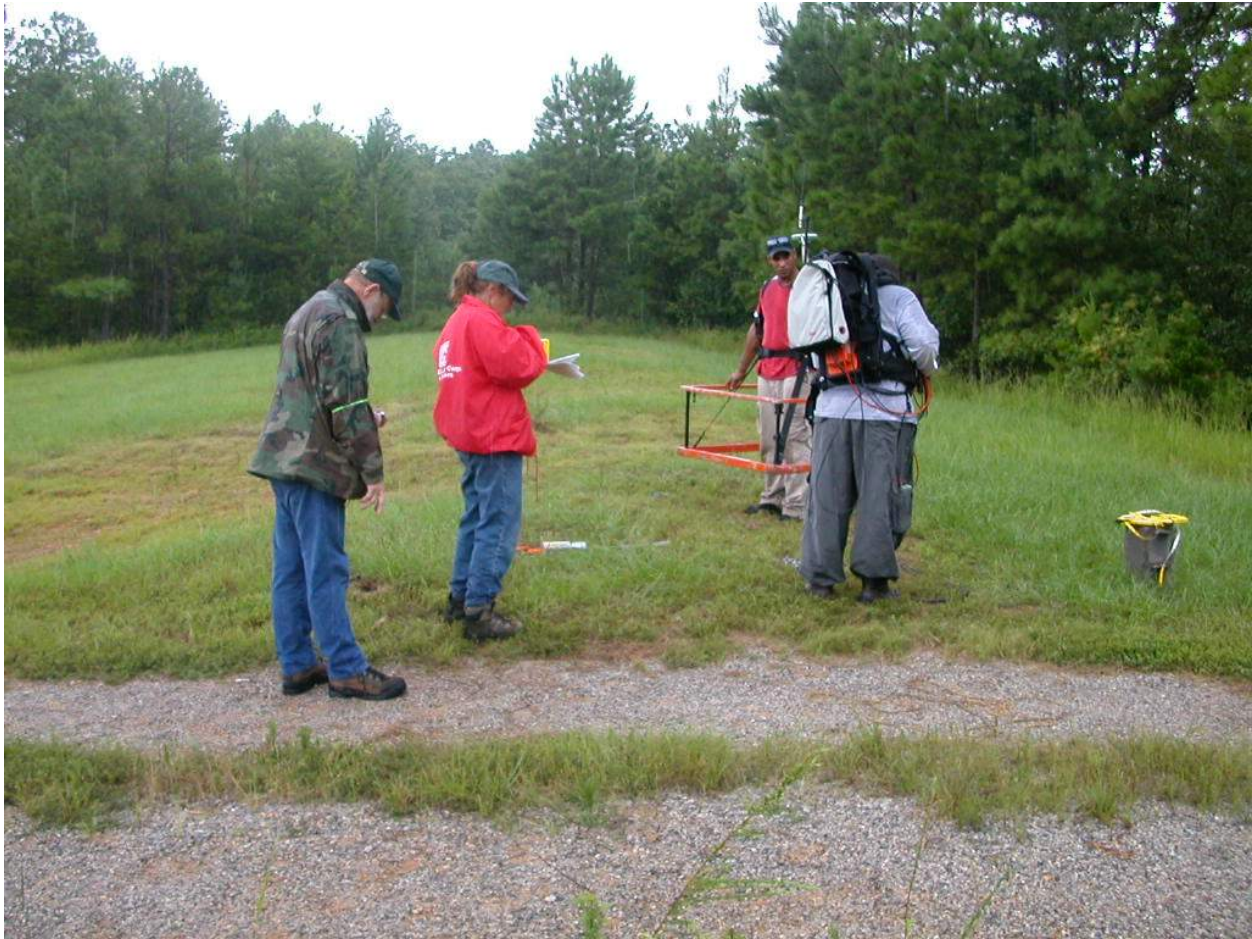
Tetra Tech EC, Inc. personnel validating geophysical equipment through the Geophysical Prove-Out (GPO) with US Army Corp of Engineers Huntsville observing.

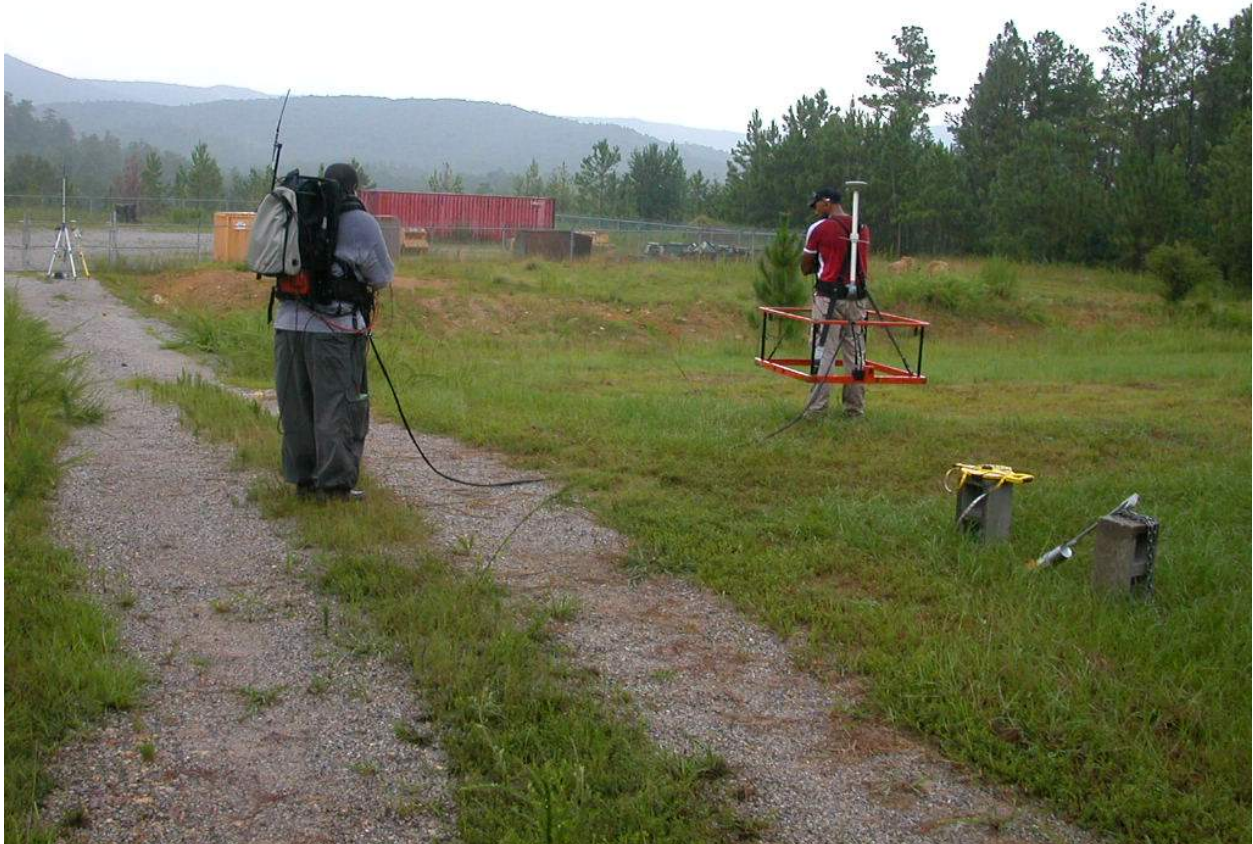
Tetra Tech EC, Inc. personnel validating geophysical equipment through the Geophysical Prove-Out (GPO).

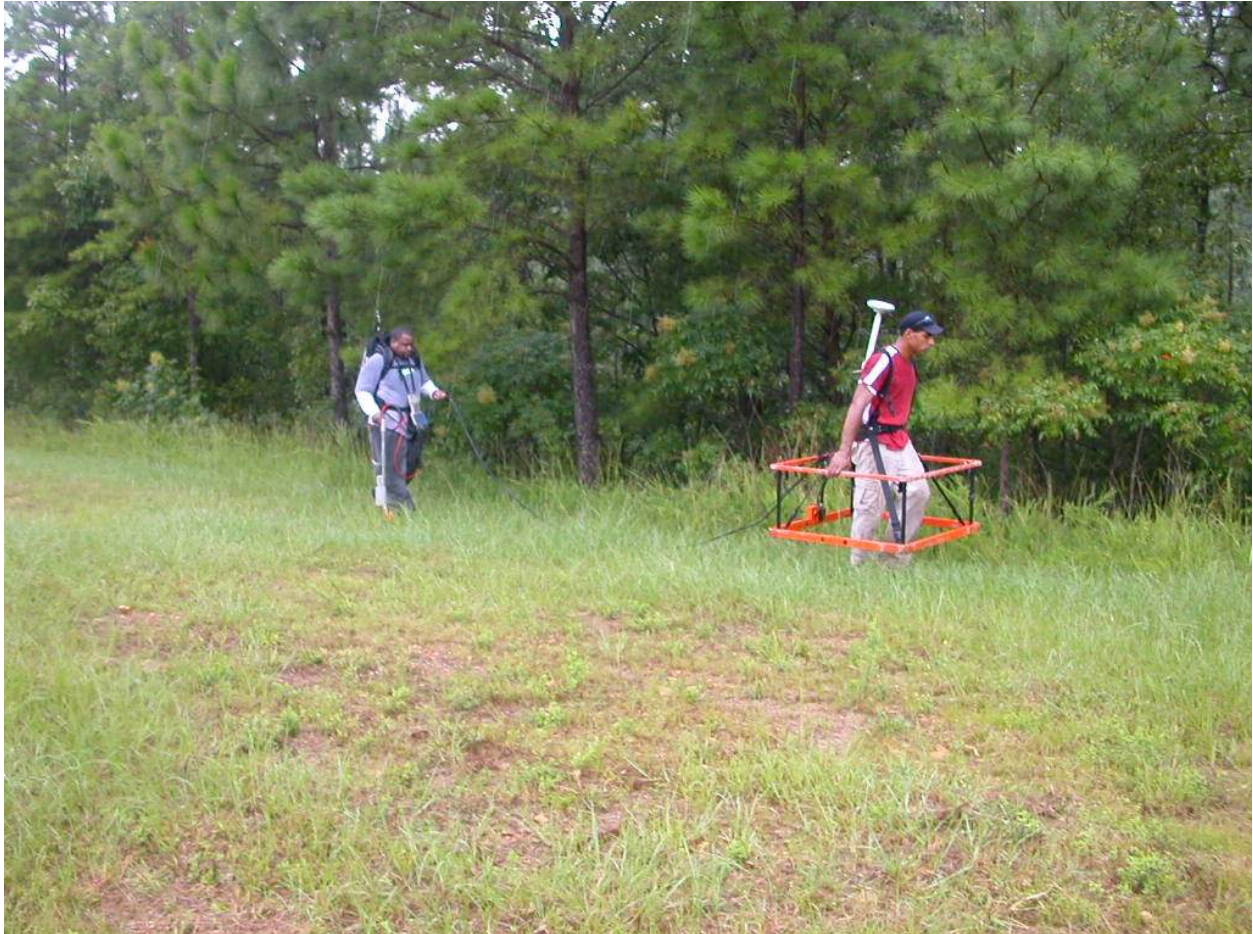
Tetra Tech EC, Inc. personnel validating geophysical equipment through the Geophysical Prove-Out (GPO).

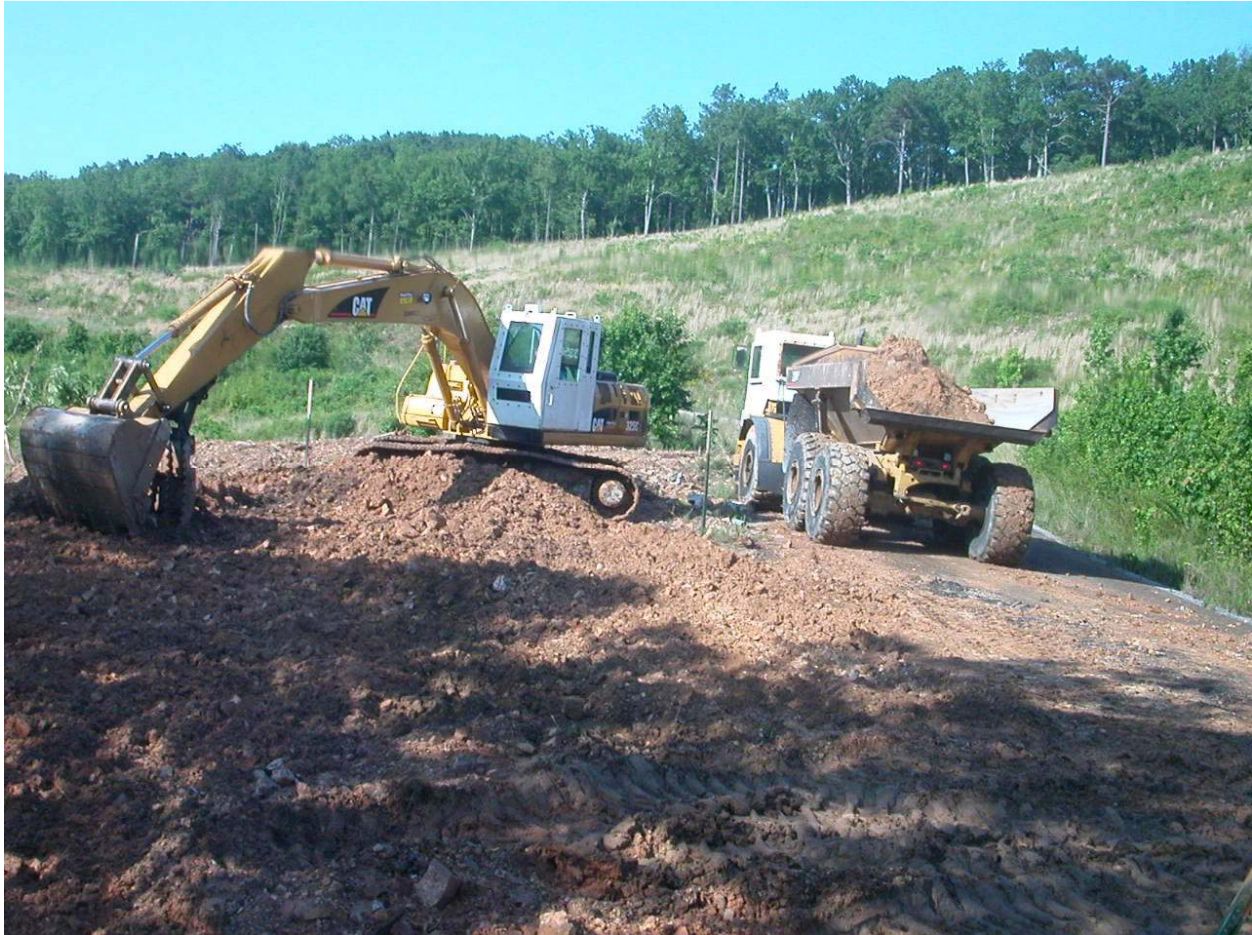
**Armored Caterpillar 325 (excavator) and armored Caterpillar 350 (articulating dump)
used for mechanical removal operations in grid C67.**

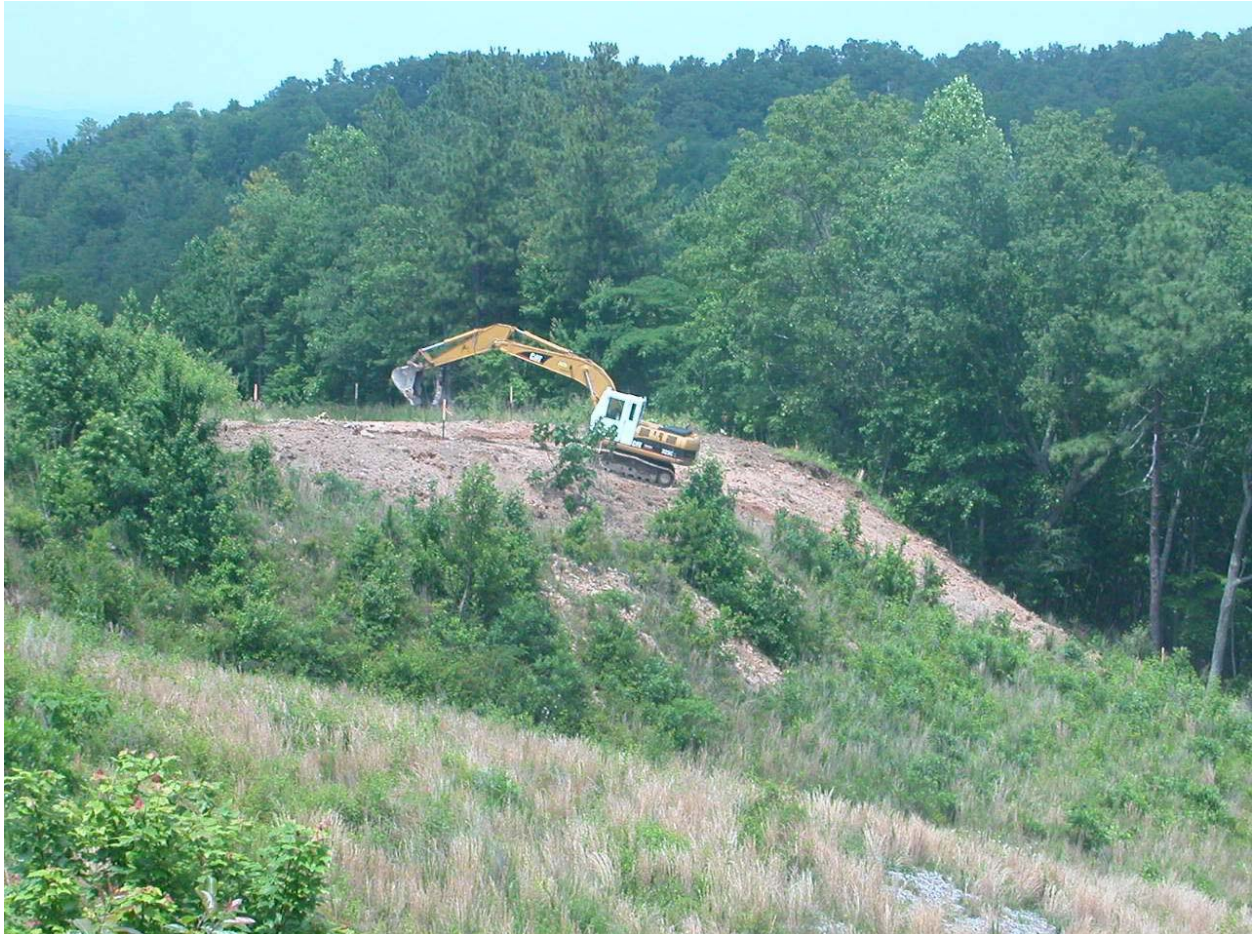
Armored Caterpillar 325 (excavator) digging in grid C67.

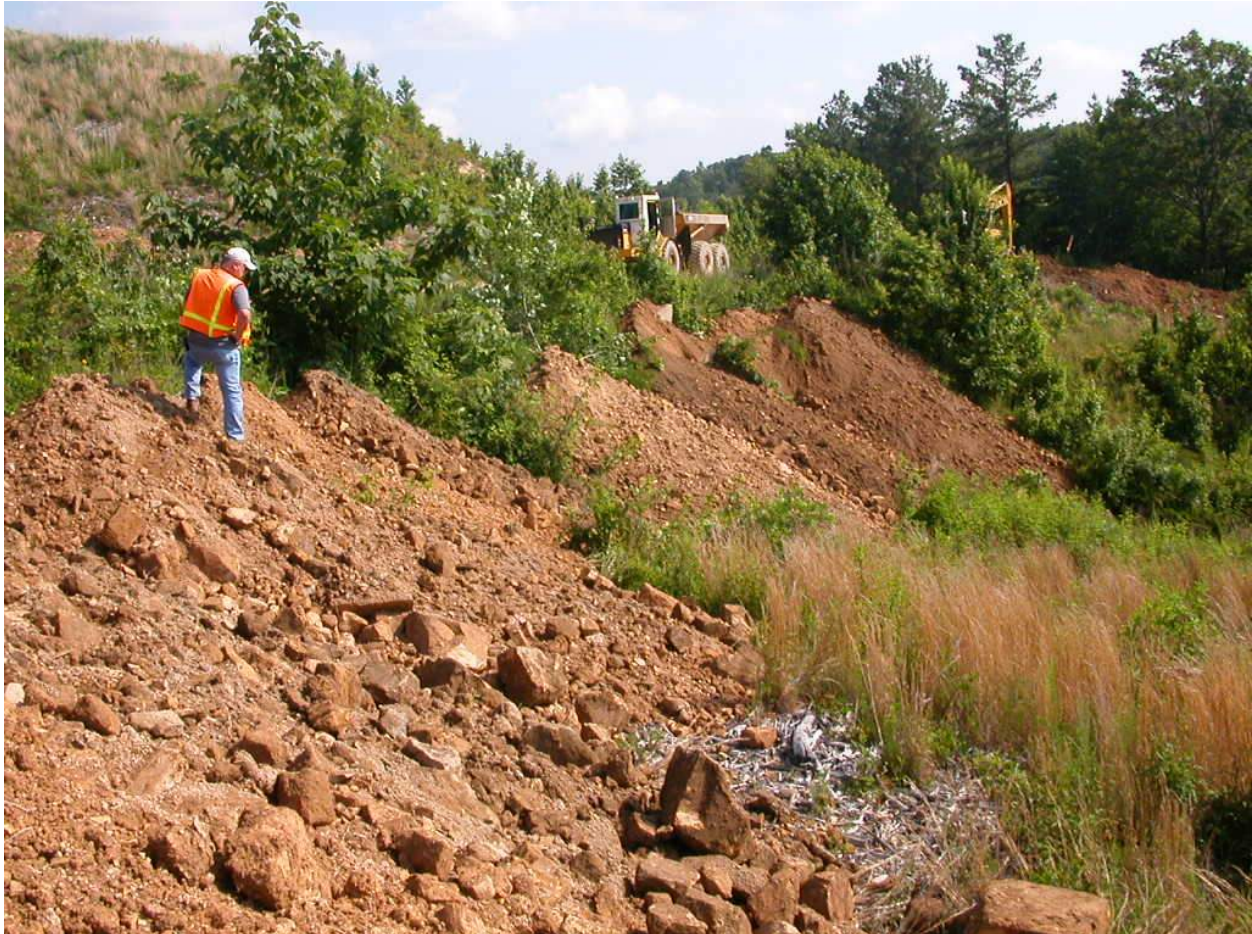
Grady Bendel (TtECI Site Quality Control) checking construction debris from grid C67.

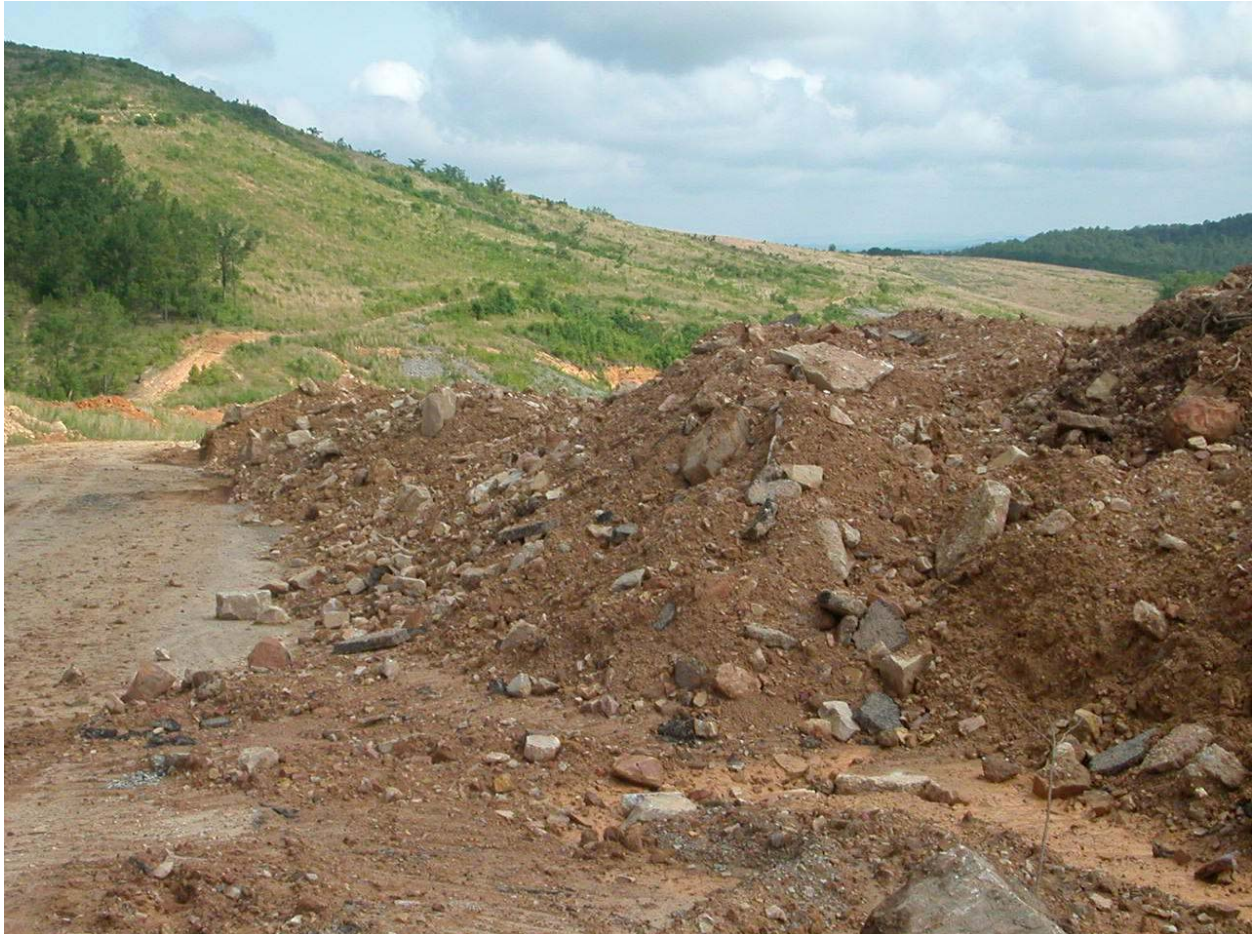
Construction debris from grid D15, South Area (SA).

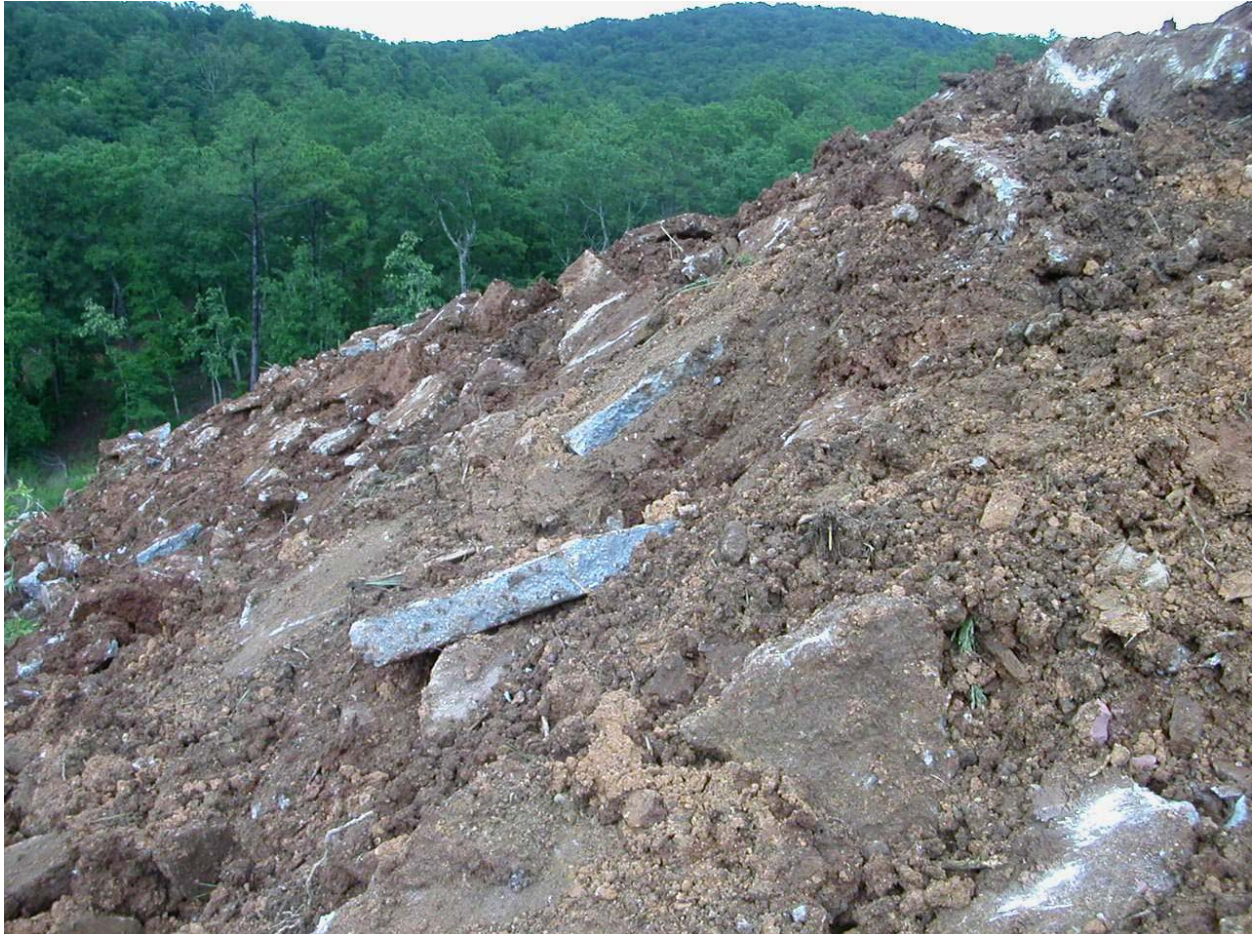
Construction debris from grid D75, Culvert area.

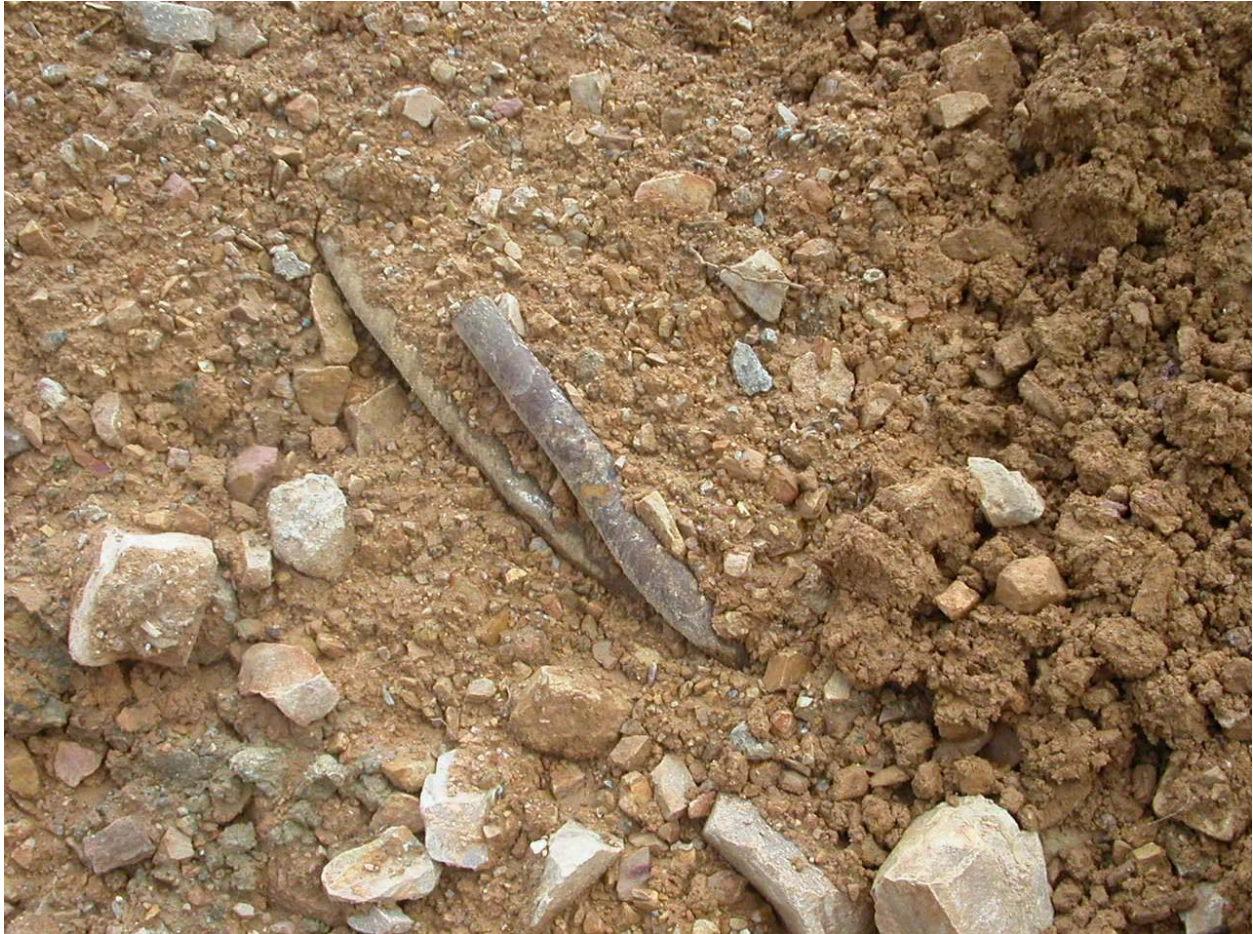
Construction debris from grid D15, South Area (SA).

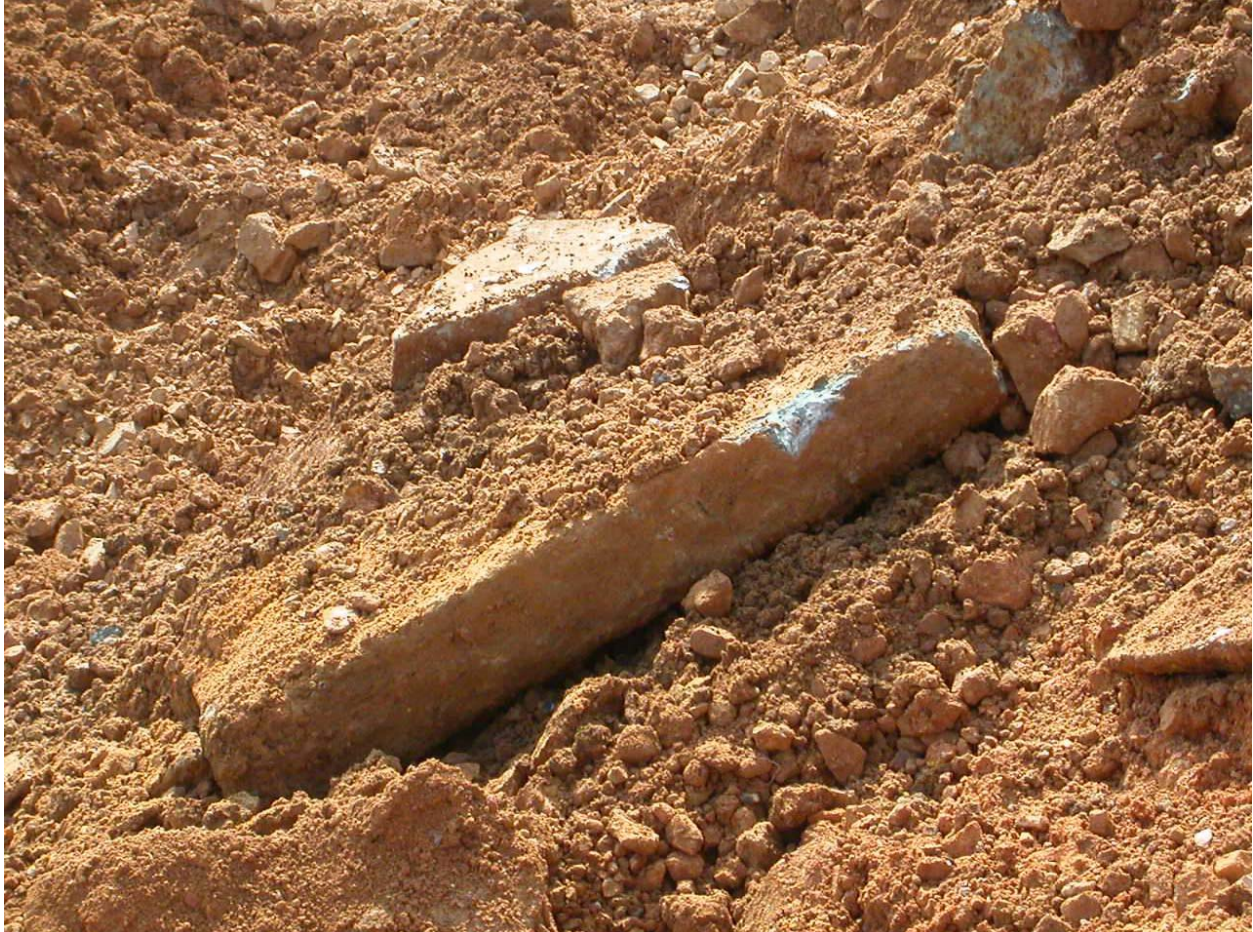
Construction debris from grid D22, South Area (SA).

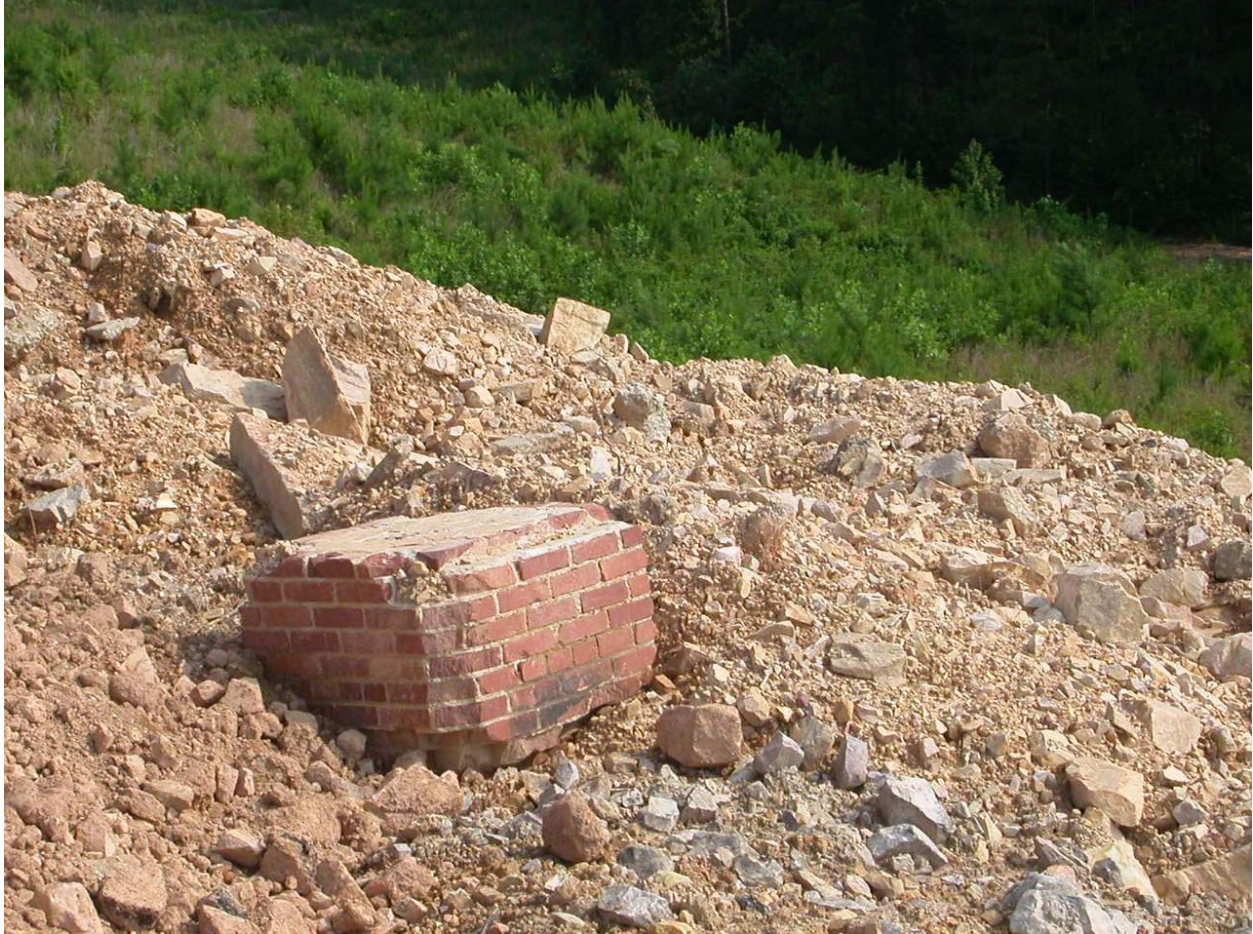
Construction debris from grid D23, South Area (SA).

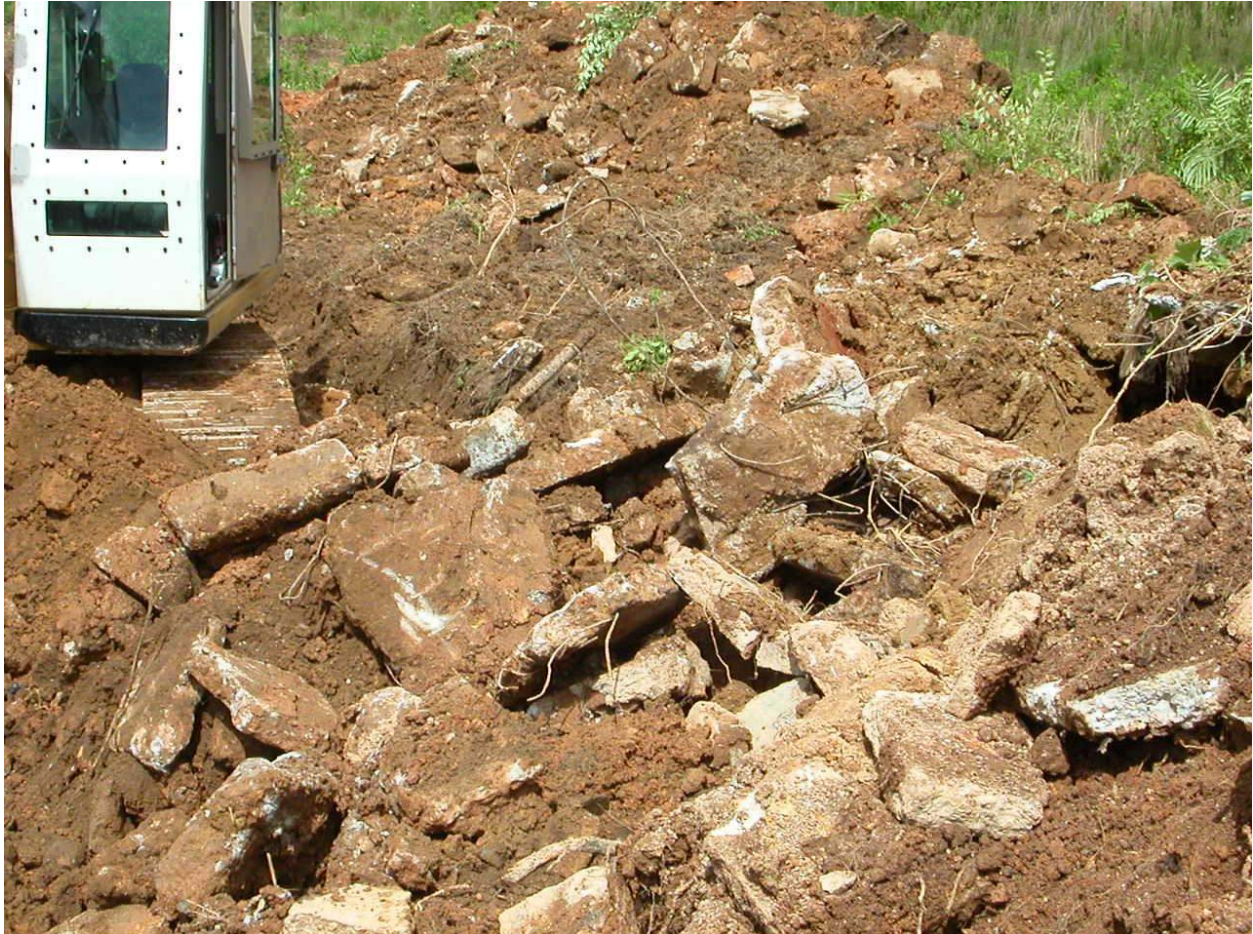
Construction debris from grid D83, Culvert area.

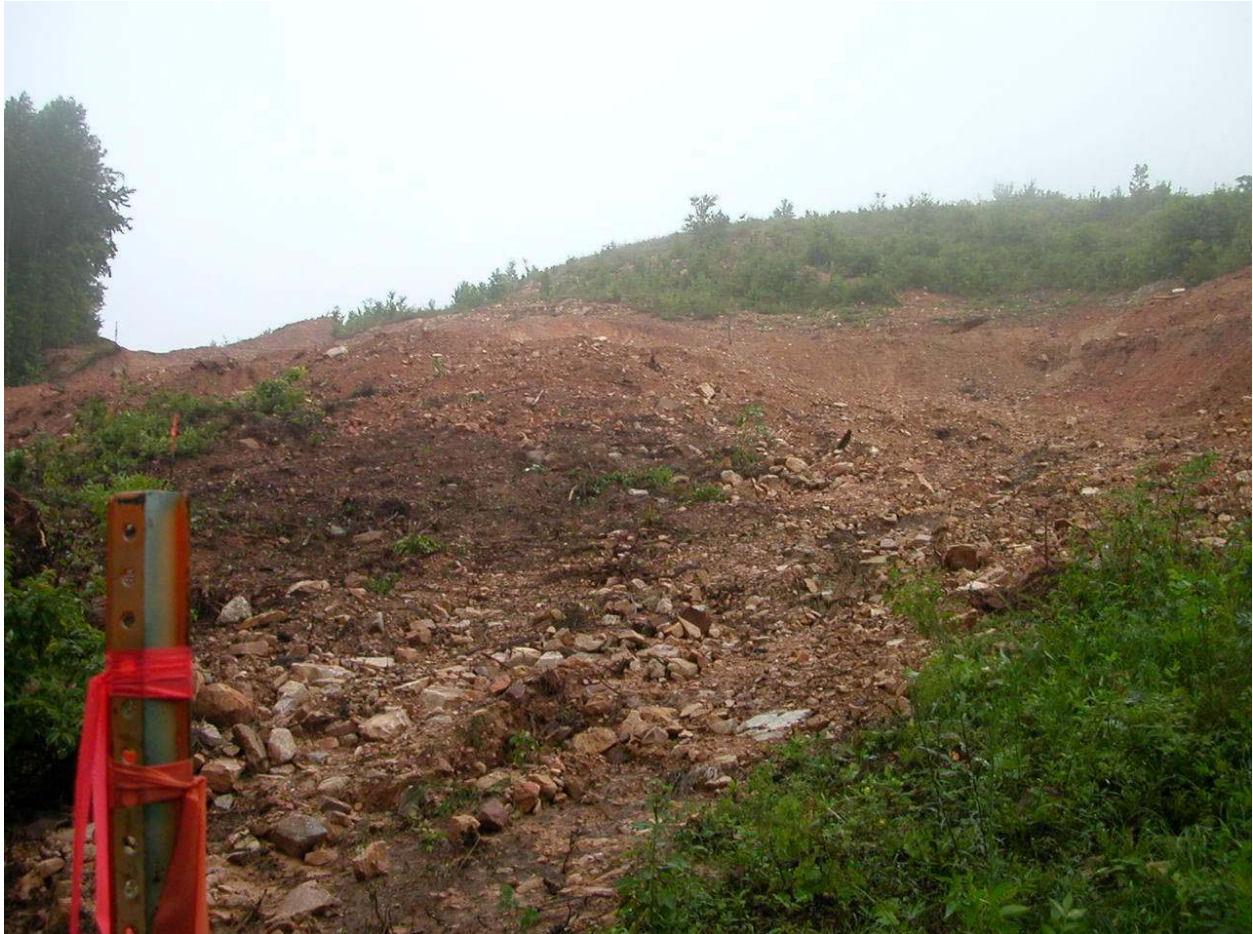
Construction debris from grid D23, South Area (SA).

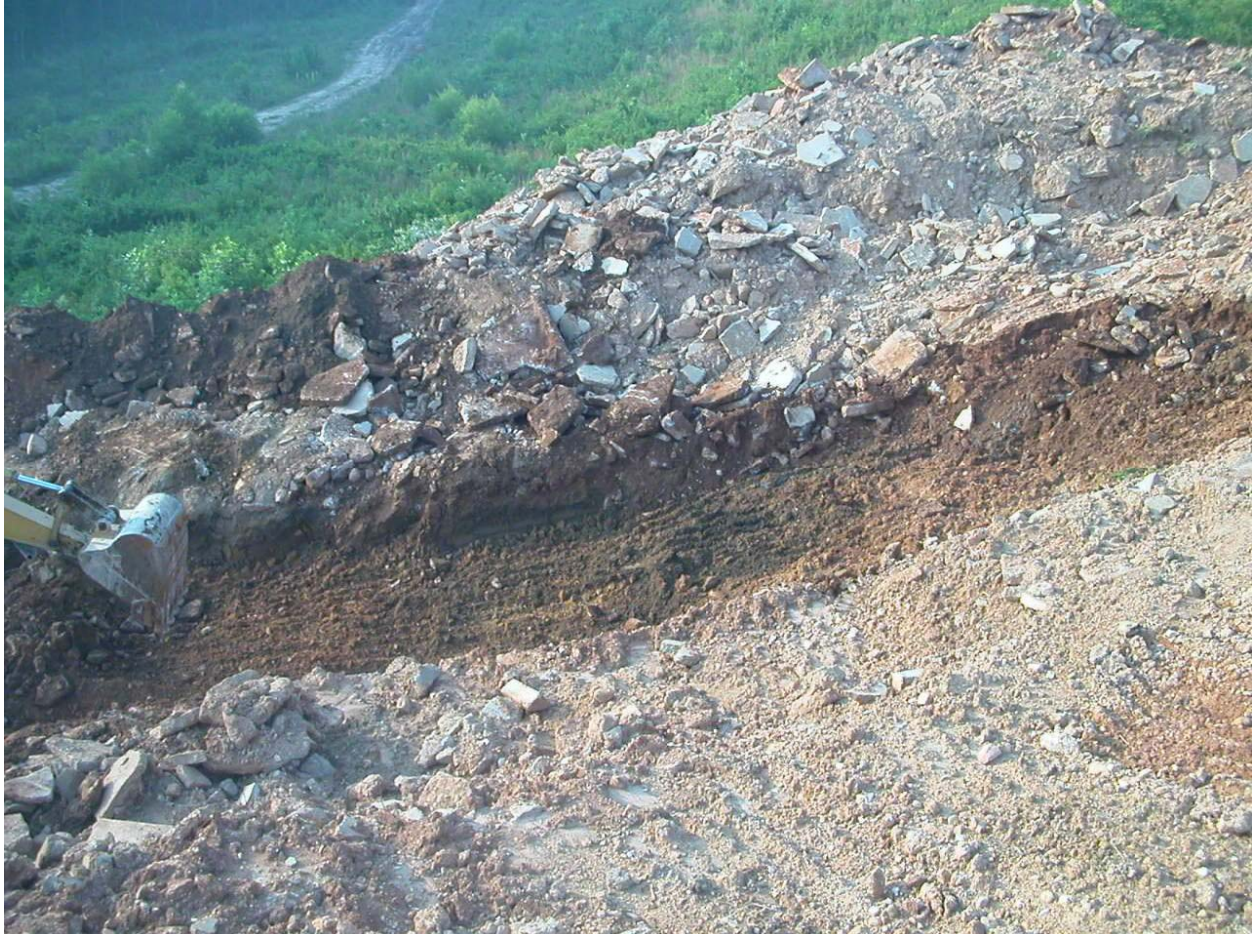
Digging in grid D83, Culvert area.

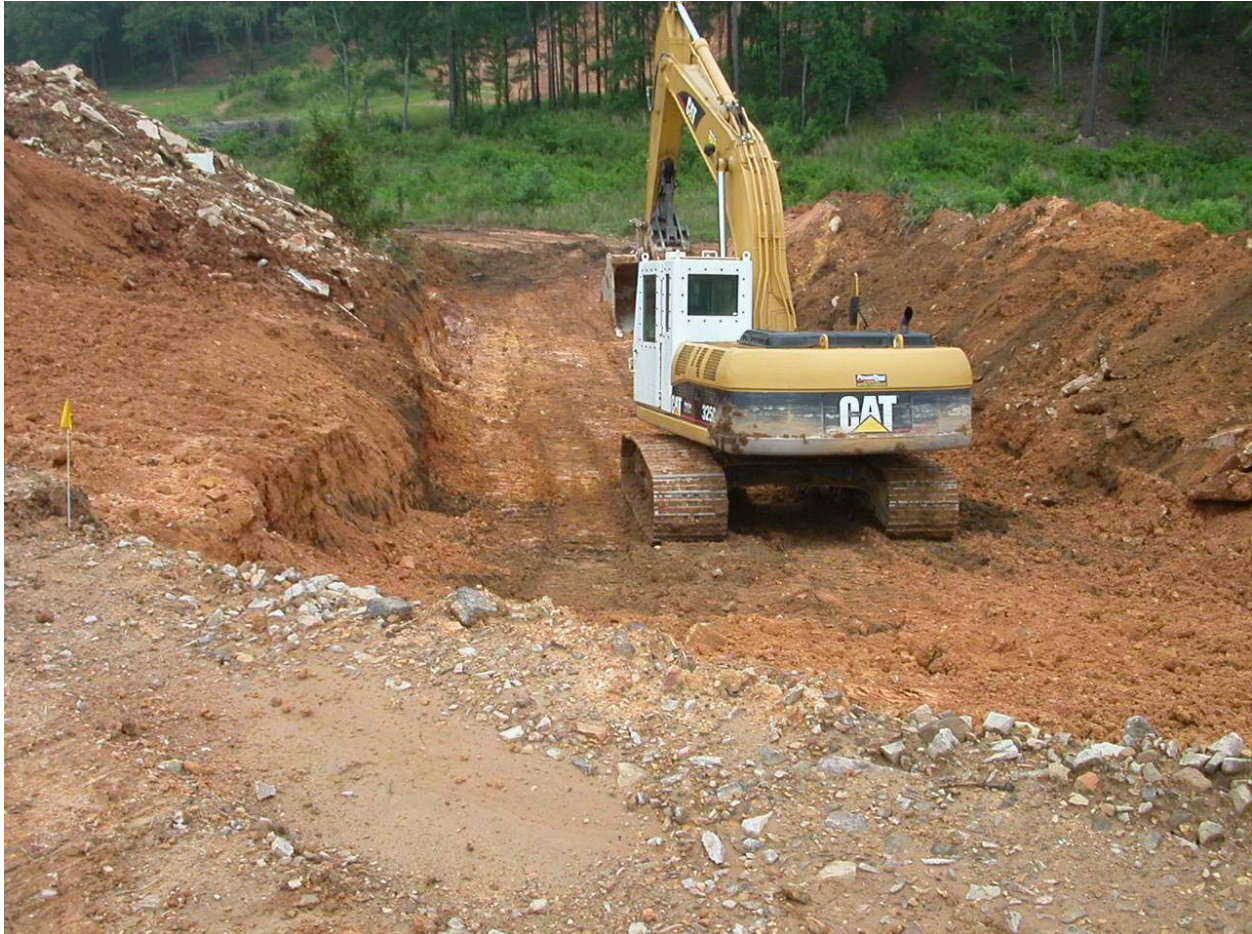
Culvert in grid D83 cleared to native soil and 20 feet wide.

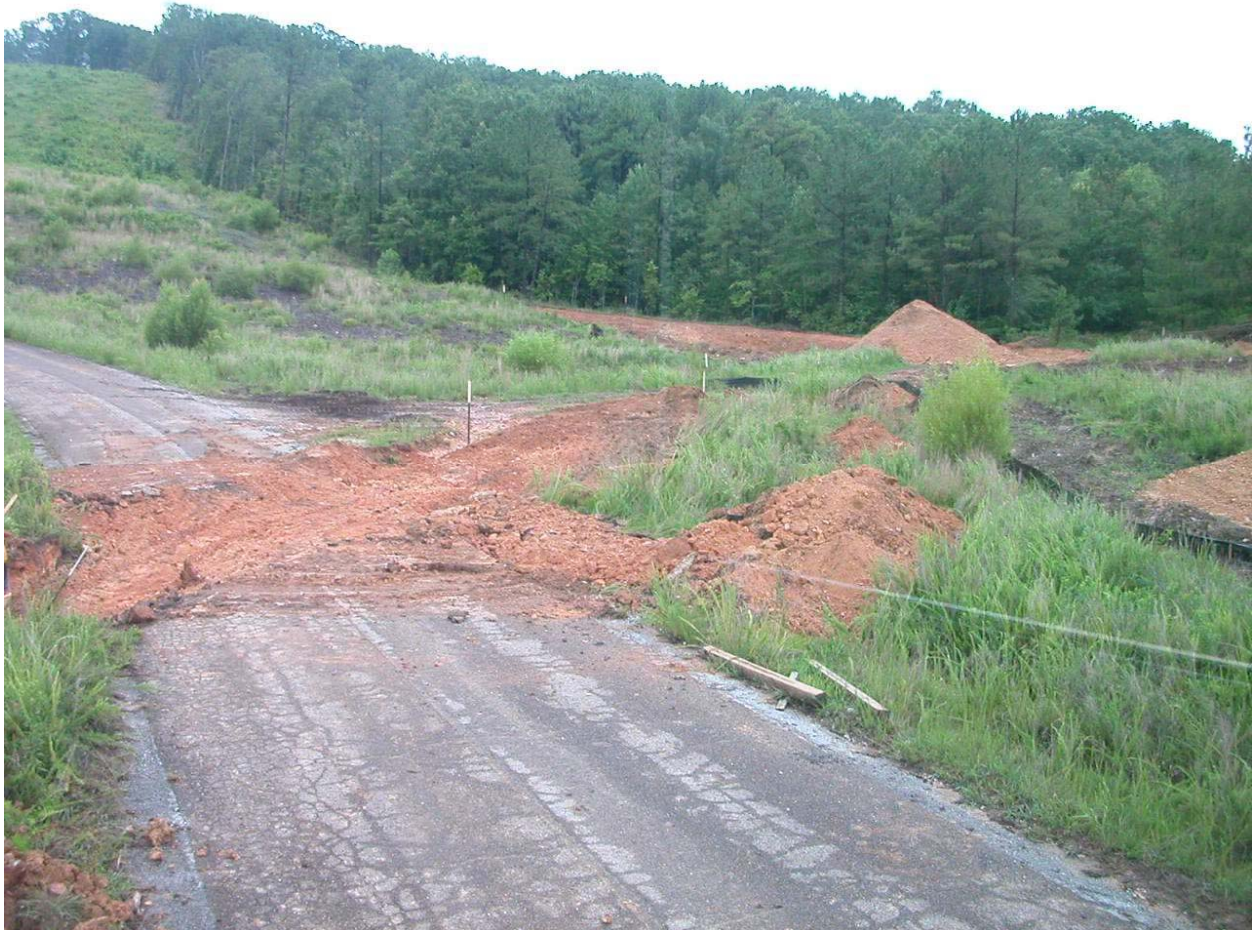
View of culvert being dug in grids D75 and D83.

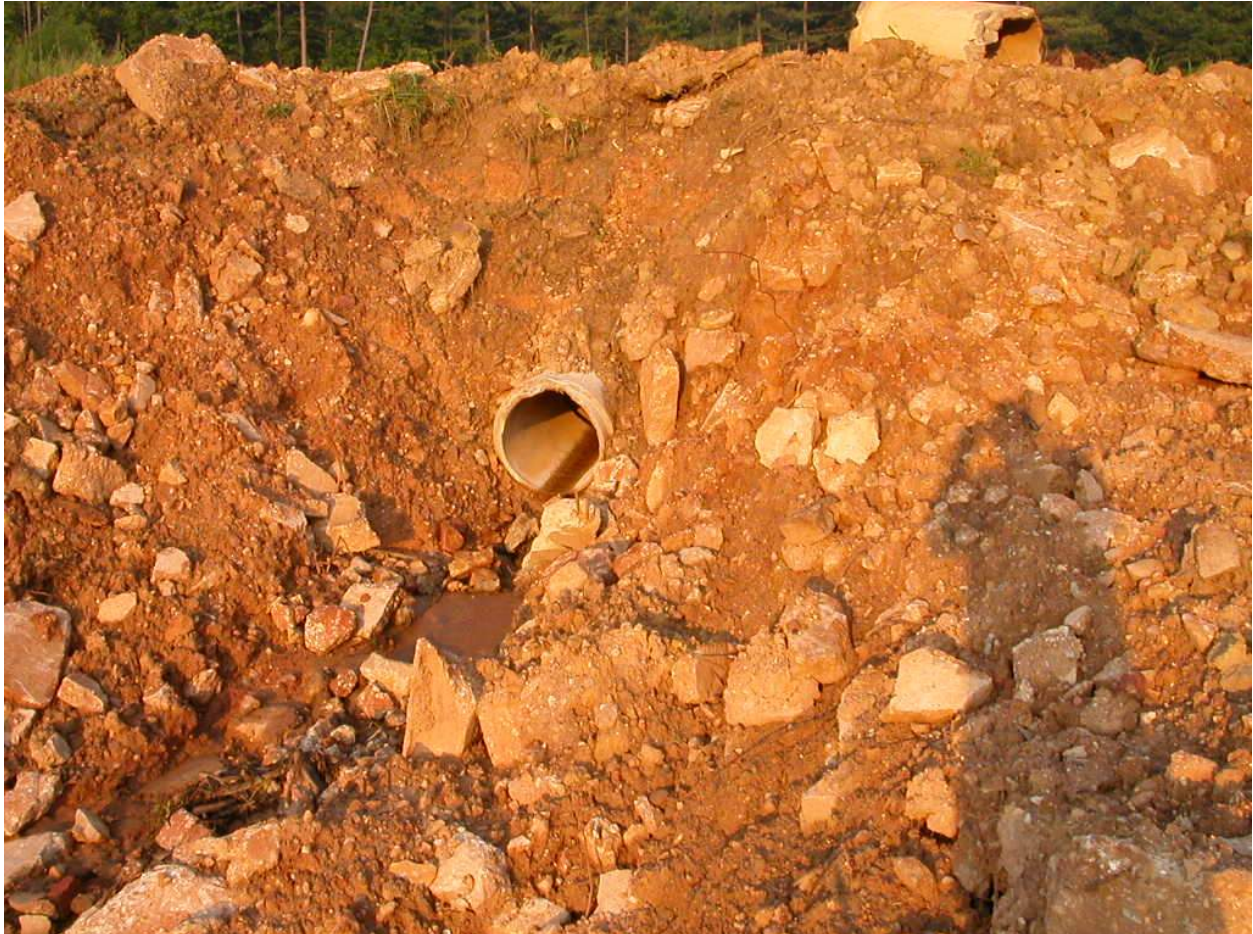
Spring box located in grid D69.

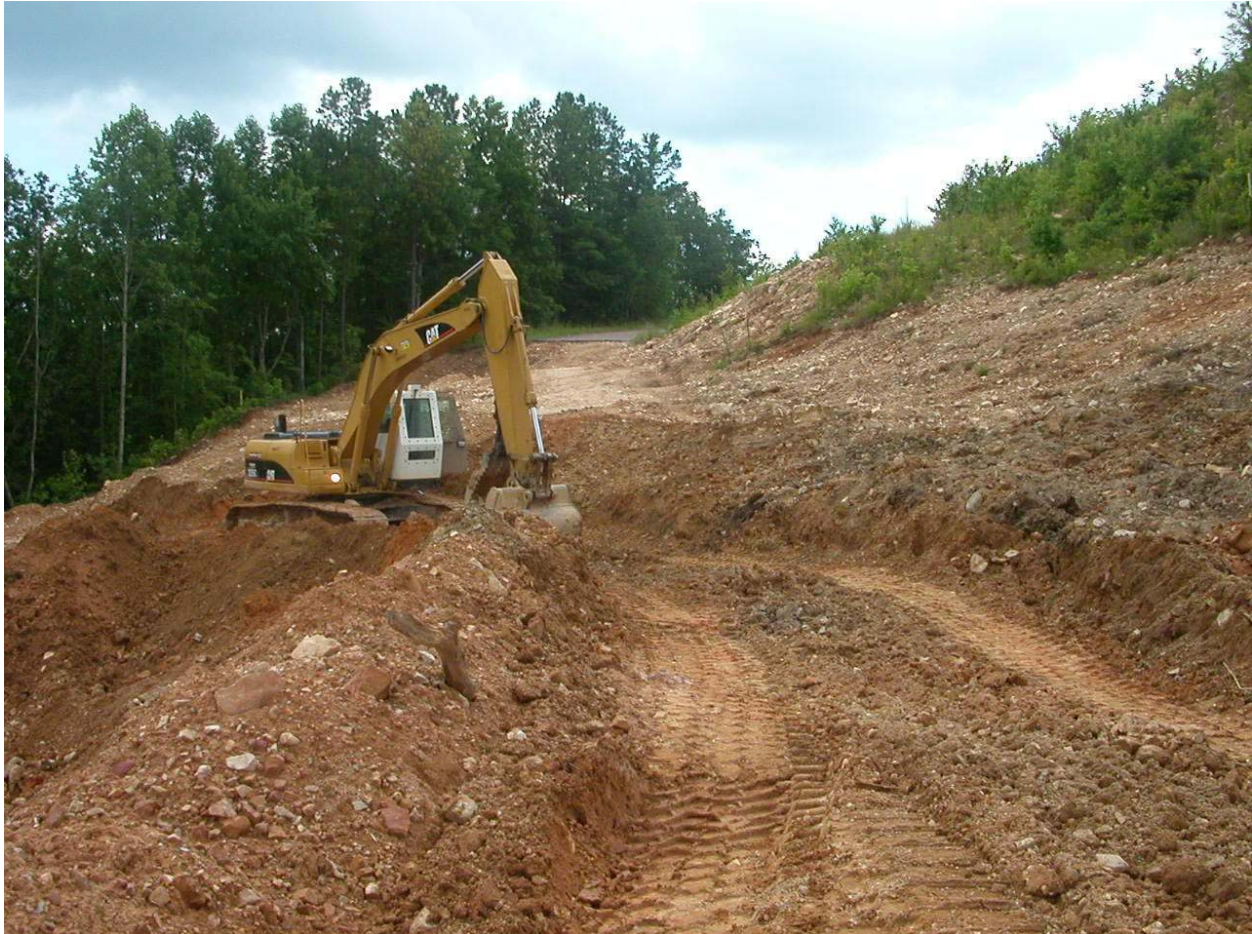
Work in grid D23, South Area (SA).
